# MAJOR ACCIDENT INVESTIGATION TEAM

## CASE SUMMARY

**CASE NUMBER:** 13-007187  
**LOCATION:** Southbound I-5 @ Skagit River Bridge, Milepost 228.47, Skagit County  
**DATE:** May 23, 2013 @ 7:05 p.m.

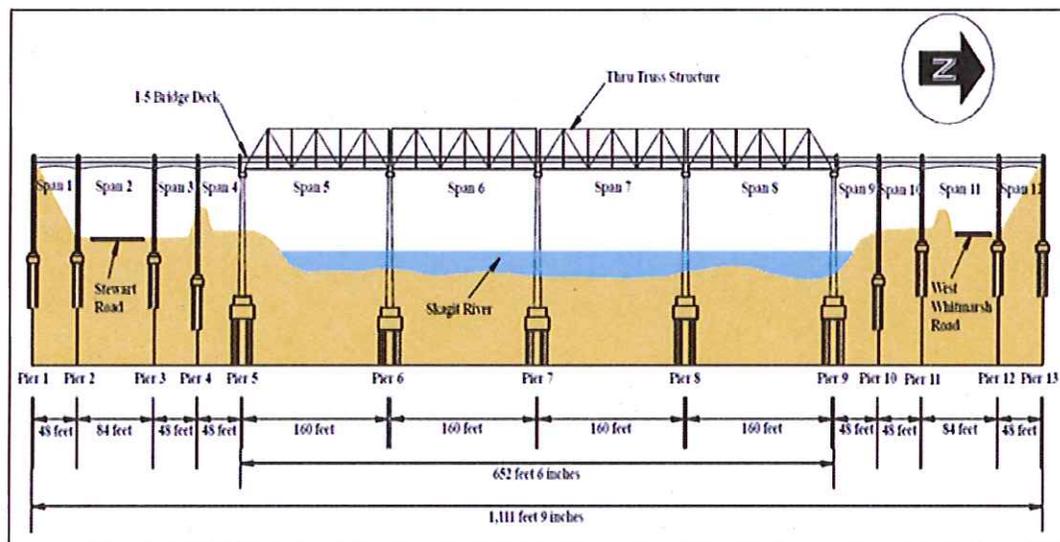
The Skagit River Bridge is classified as a Fracture Critical Bridge, meaning there is one or more steel members in tension arranged such that if one fails, a portion or all of the bridge could collapse. This bridge had 22 pieces in each Thru Truss Span which were identified as fracture critical members.<sup>6</sup> None of the vertical fracture critical members of the dropped span had noted defects. The diagonal fracture critical members could not be inspected near the bottom due to dirt and vegetation obscuring the lower joint. The report also noted that the west side bottom chords all had some form of rust or pitting. The collision occurred with the Thru Truss Structure on span eight of 12 as shown in the following diagram<sup>7</sup>:

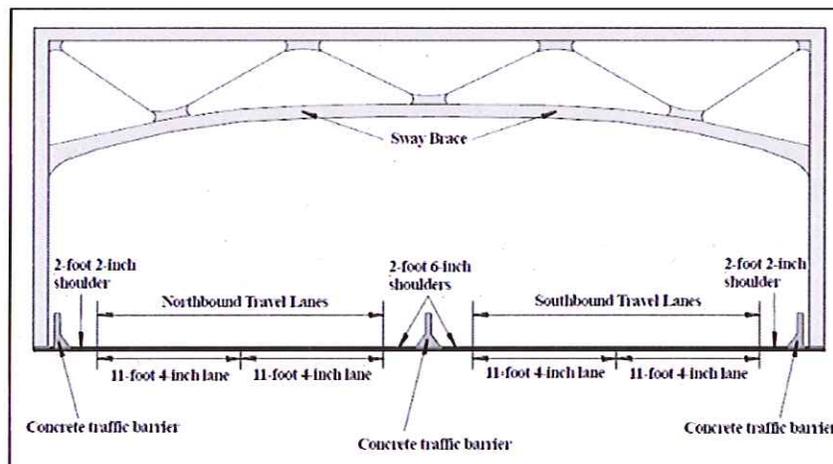
The above diagram<sup>8</sup> depicts a cross section of the bridge showing roadway layout. There are two 11'4" wide lanes in each direction as measured from the center of the painted edgelines to the center of the lane dividers. North and southbound I-5 are divided by a center concrete traffic barrier. There are 2'6" paved inside shoulders and paved 2'2" outside shoulders to the concrete traffic barrier.

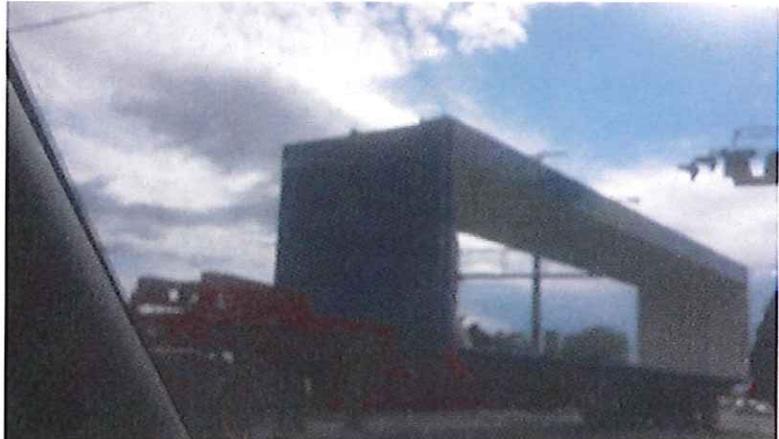
Witness Janine Sande was near this intersection at about 5:50 p.m. when she saw the wide load turning right onto (southbound) SR 9 from S. Pass Road. In her statement to Detective Greg Wilcoxson, Sande said she saw the wide load passing under the overhead railroad warning lights and the driver appeared unsure about his clearance height. Sande felt the pilot car driver (male) and the wide load driver were unprofessional so she took a photo (right) of the situation with her cell phone.

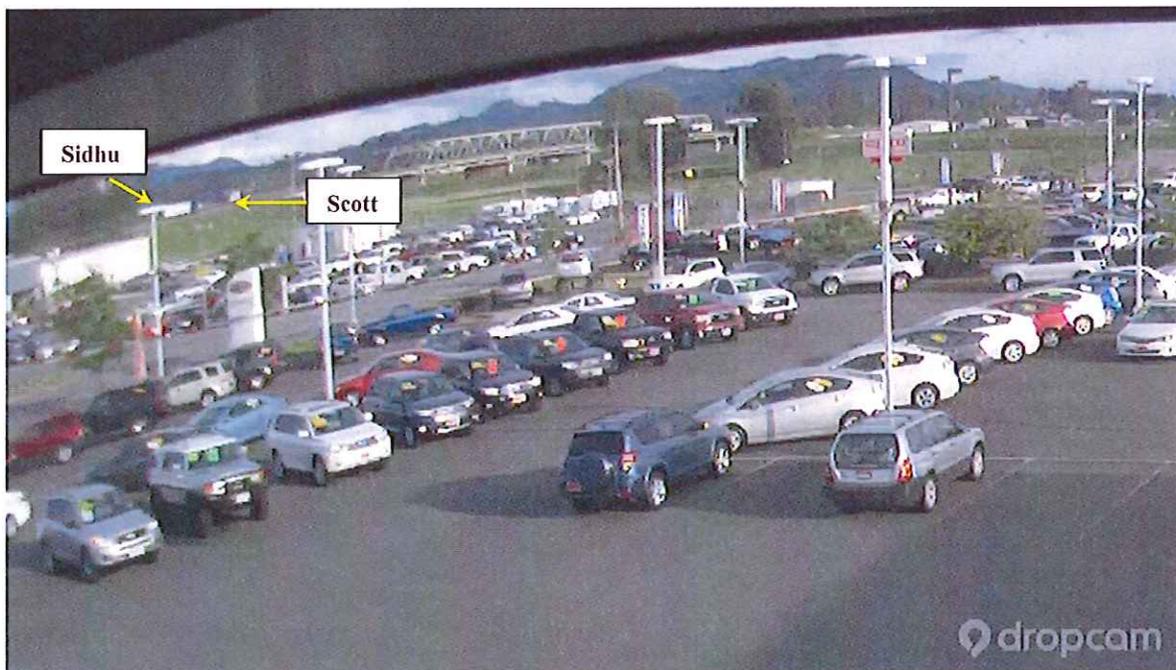
Scott said he was going approximately 56 ~ 58 mph as he entered the bridge. He told investigators that the pilot vehicle was approximately half way across the bridge in the right lane (550 feet); or about a half a mile ahead with plenty of distance for him to stop if the pilot driver alerted him. Scott stated that a white tractor combination was passing him, moving fast and “squeezing” him. This truck was in fact Amandeep Sidhu. The photo below taken from Foothills Toyota surveillance video shows both trucks on the bridge right before the collision.
