Consolidated Forensic Laboratory Report

FORENSICS DIVISION
Facilities Master Plan
Washington State Patrol

**FACILITIES
MASTER PLAN**

4.0 Existing Conditions

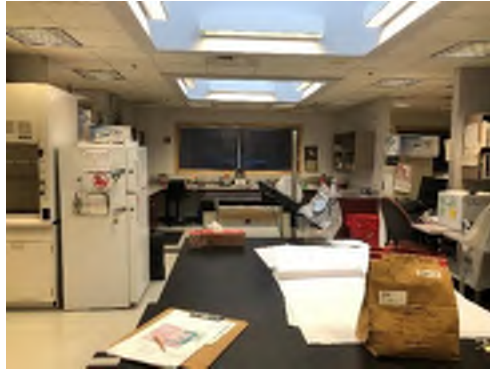
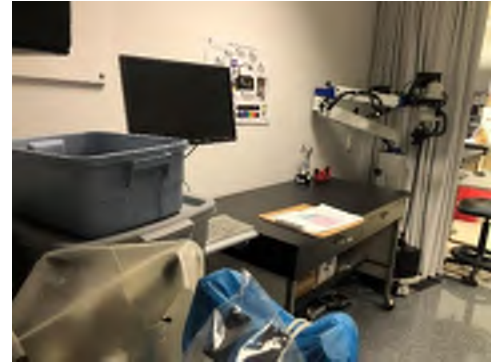
Shared exam tables on the open lab area.

There are no dedicated exam rooms. Examination of evidence takes place on common worktables in the open lab area. This is a severe impact on efficiency of workflow as any investigation/processing has to be scheduled for a single work time as it is impossible to secure in place if the task takes longer than a single shift. This also contributes to possible cross contamination.

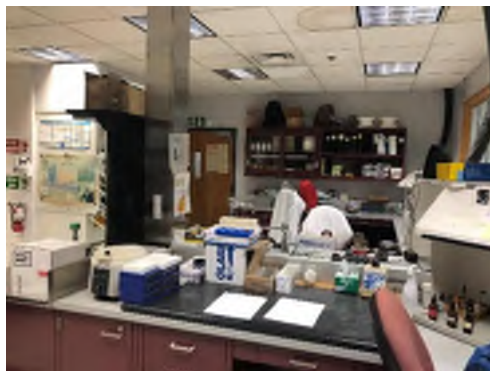
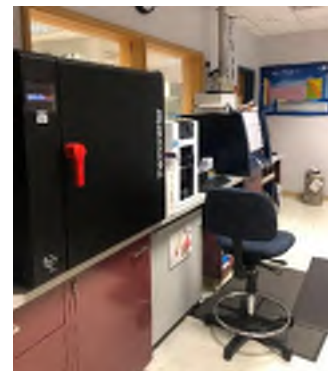
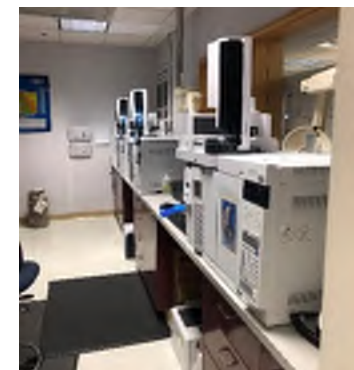
Chemistry Lab

The adjacent instrument room is cramped and overcrowded. It has no capability for increasing equipment in support of staffing growth.

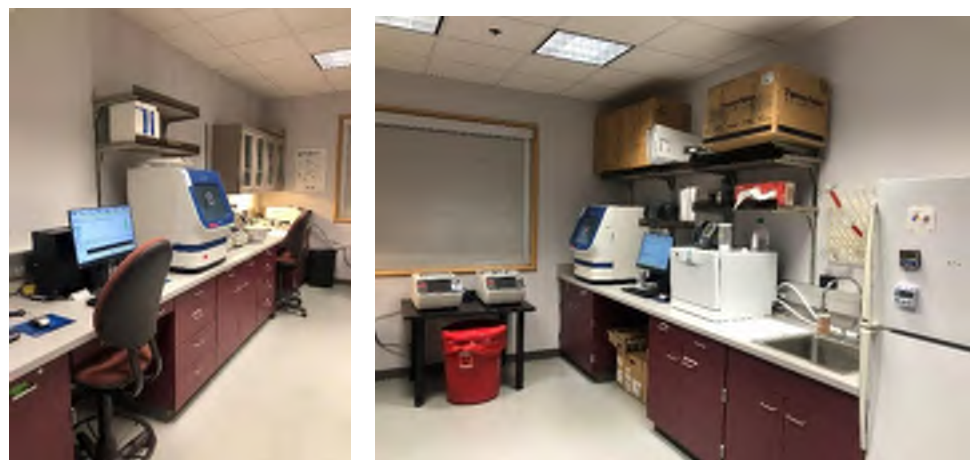
PCR lab

The adjacent Extraction, PCR Set-Up, and Post-Amplification labs have been made to work for current use; however, there is insufficient space to fit the desired amount of instrumentation.

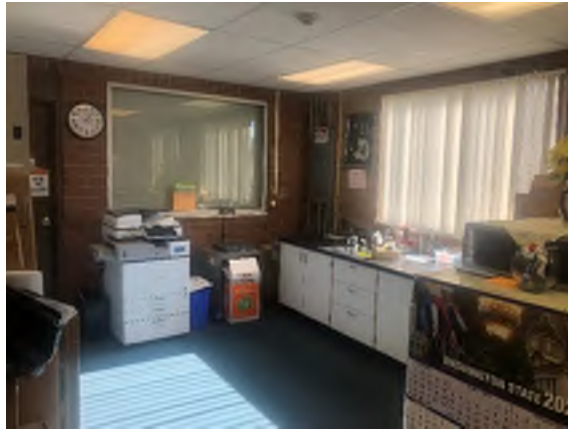
Evidence processing in administrative space

- *Public Access*
There is little or no public access to the lab except for served agencies and delivery services dropping off evidence parcels.
- *Evidence*
The intake is provided with a secure vestibule with a pass window that does not appear to be used. There is administrative space for two property and evidence custodians. Evidence processing occurs in the administrative area. There is no room provided for evidence viewing. The main evidence storage area is provided with some interior caging. It generally appears to accommodate current need. There is a smaller evidence storage room off the lobby that has locked cabinets and appears to be adequate size for current needs. There is no capability for future expansion.

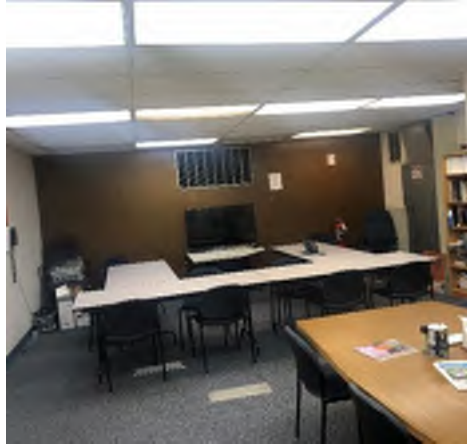
Classroom

The classroom/break lab is serviceable for the assigned staff. The lack of daylight and vestiges of exposed HVAC in the room contributes to a worn and negative environment.

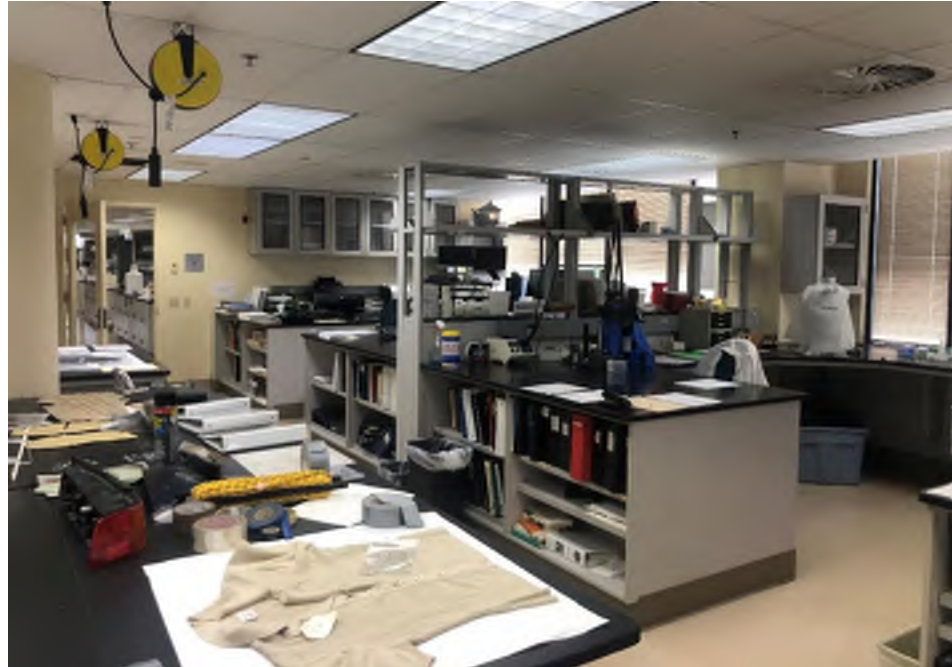
Located in the southeast corner of floor three, MA Lab entrance corridor has a wash station but is not configured as a controlled vestibule. There are six “U” shaped workstations in the lab. Two exam rooms, a SEM analysis room, a secure reference storage and small evidence room are included. This space appears adequate for current and projected use.

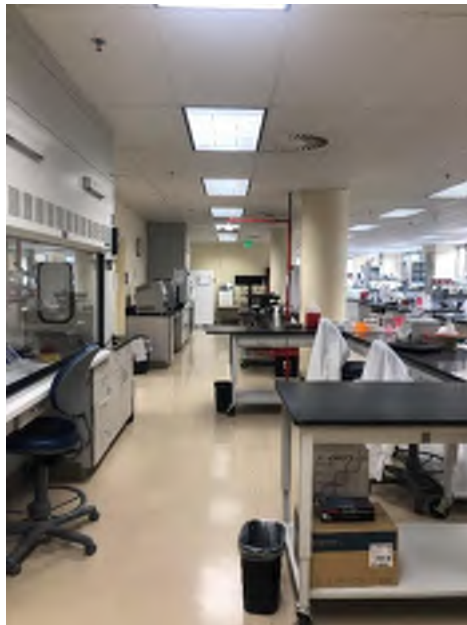
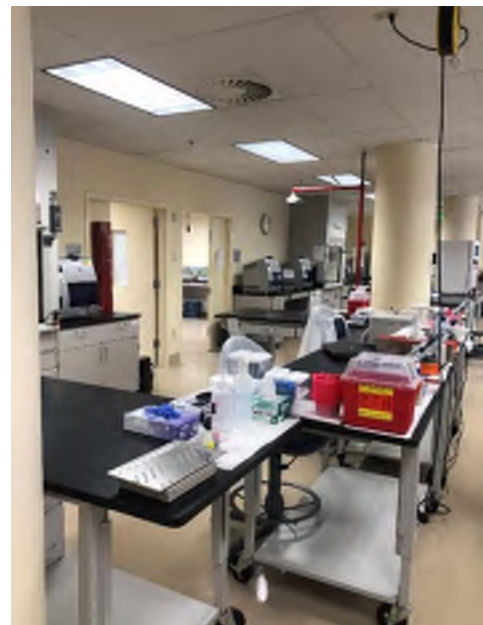
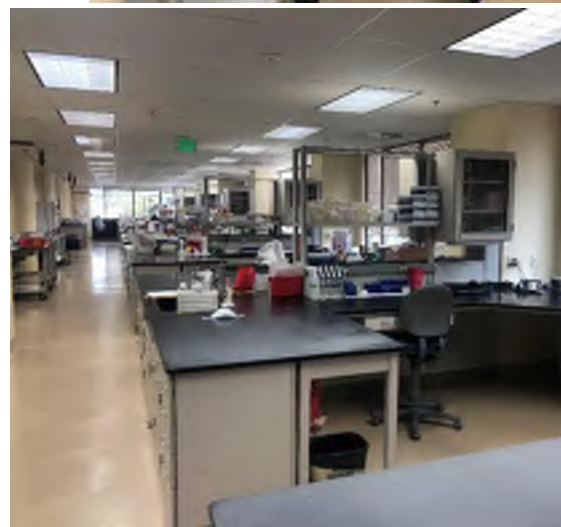
DNA Lab

The adjacent Extraction, PCR Set-Up, and Post-Amplification labs have been adequate for current use; however, fitting the amount of instrumentation in the current benching has been difficult. In the future, it is anticipated that new instrumentation will be smaller in size and will mostly be accommodated in the current space.

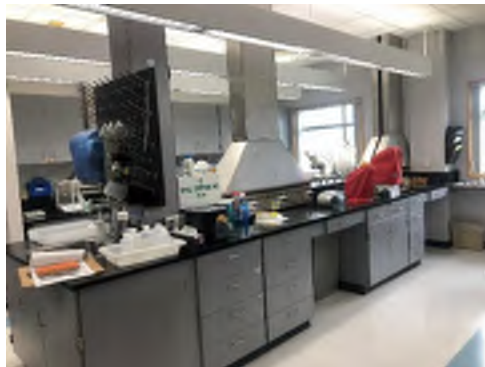
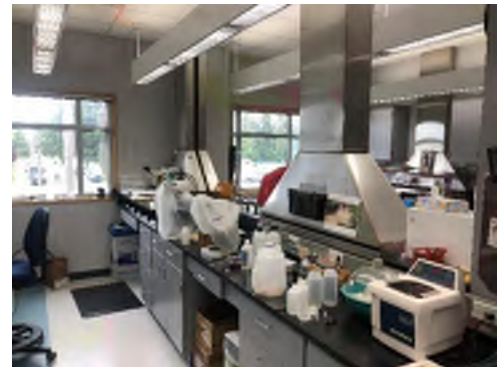
MA/Chemistry Lab

- *Microanalysis/Trace/Chemistry Lab*
The MA and Chemistry functions are “blended” at the lab owing to the lack of separate spaces for these functions. This area of the lab was renovated in 2011 and, with the exception of inadequate size, appears to function adequately.

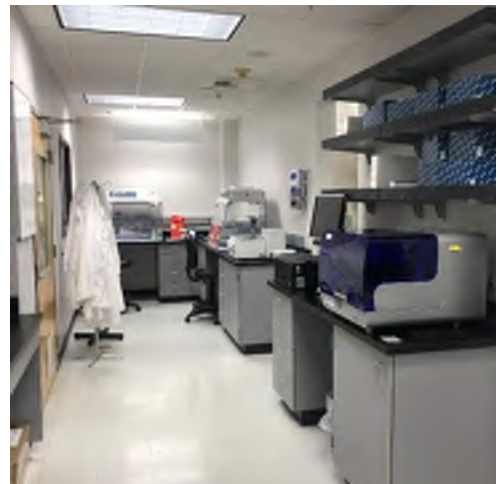
DNA Lab

The DNA lab area provides fixed casework at the perimeter and movable tables at the center. It accommodates six scientists and one lab tech. The adjacent Extraction, PCR Set-Up, and Post-Amplification labs have been adequate for current use
