# MAJOR ACCIDENT INVESTIGATION TEAM

## CASE SUMMARY

**CASE NUMBER:** 13-007187  
**LOCATION:** Southbound I-5 @ Skagit River Bridge, Milepost 228.47, Skagit County  
**DATE:** May 23, 2013 @ 7:05 p.m.

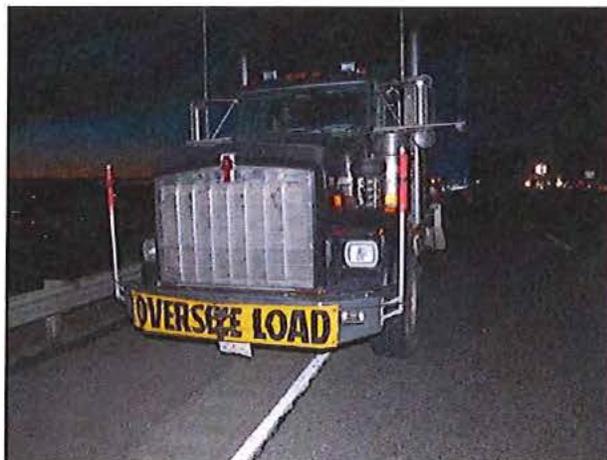
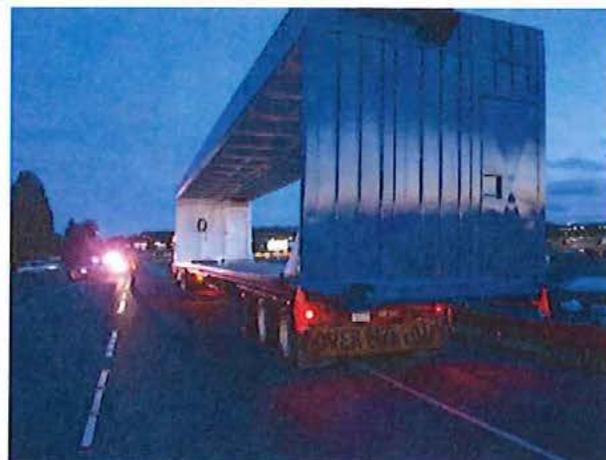
**Black 2010 Kenworth Tractor/Red 1997 Aspen Flatbed**

Both the Kenworth trailer, Alberta license H54041, and Aspen trailer, Alberta 4ER573, were registered to Mullen Trucking. The three-axle tractor was equipped with a Caterpillar C15 diesel engine, 18 speed Fuller Eaton manual transmission, and a pneumatic Anti-lock Brake System (ABS). The steer axle was equipped with Bridgestone tires in size 385/65/R22.5; axles two and three were equipped with dual wheel, Michelin tires in size 11R/24.5. The tractor was licensed for 92,000 pounds as an interstate transporter (USDOT number 158799). The driver's seat is equipped with a lap and shoulder harness safety belt which driver Scott was wearing. There is no airbag supplemental restraint system. Affixed to the front bumper was a black lettered/yellow background "OVERSIZE LOAD" banner.

According to the National Highway Traffic Safety Administration (NHTSA), there were eight recalls and 50 service bulletins for this vehicle. None of the recalls contributed to this collision. According to the NTSB Vehicle Group Chairman Factual Report (page 14), the tractor and trailer were maintained properly and had passed current safety inspections. The Aspen three-axle step bed semi-trailer connected to the tractor with its kingpin to the fifth wheel receiver. All three axles are equipped with air brakes. The trailer was hauling a blue metal open sided casing shed. Including the load, the total trailer length measured as 70'5", width of 11' 6", and overall height<sup>2</sup> of 15'11". The oversize load permit allowed a trailer length of 70'4", width of 11'6", and a height of 15'9". Attached under the bumper was a similar "OVER SIZE LOAD" banner.

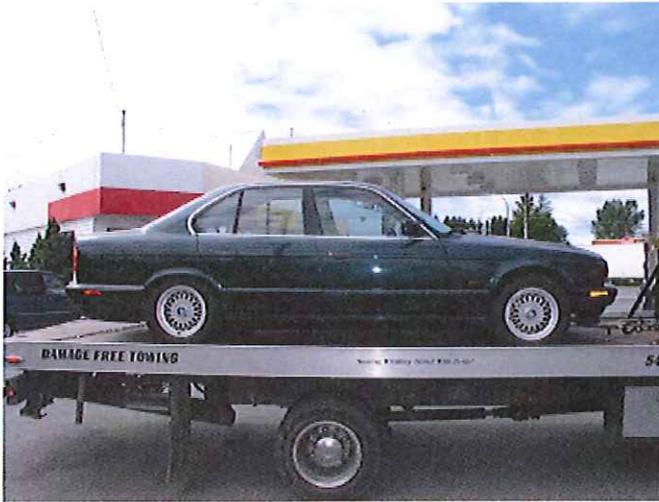
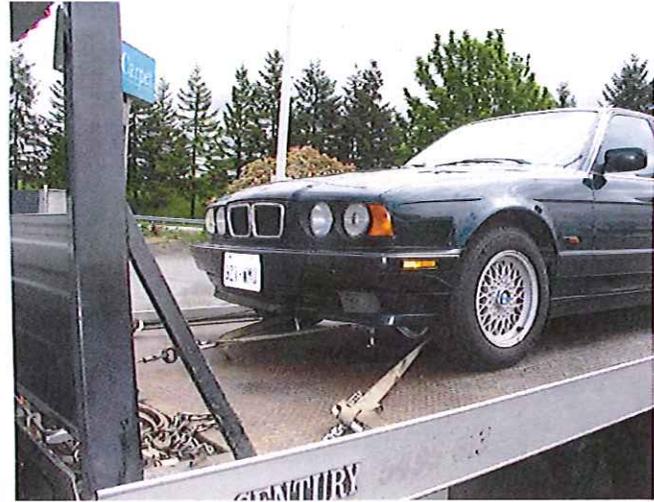
The BMW, Washington license 921WMU, is registered to David Ruiz. It was equipped with a 2.5L L6 12V SOHC engine, 4-speed automatic overdrive transmission with rear wheel drive, 4-wheel disk brakes with ABS, and power steering. Michelin size 205/65R15 radial tires were mounted on all four wheels. The front and outer rear seats are

equipped with three point lap/shoulder belts; the middle rear is lap only. The front seats are equipped with airbags and outboard head restraints.

According to NHTSA, there were 15 complaints and one service bulletin for this vehicle. None would have an effect on this collision.

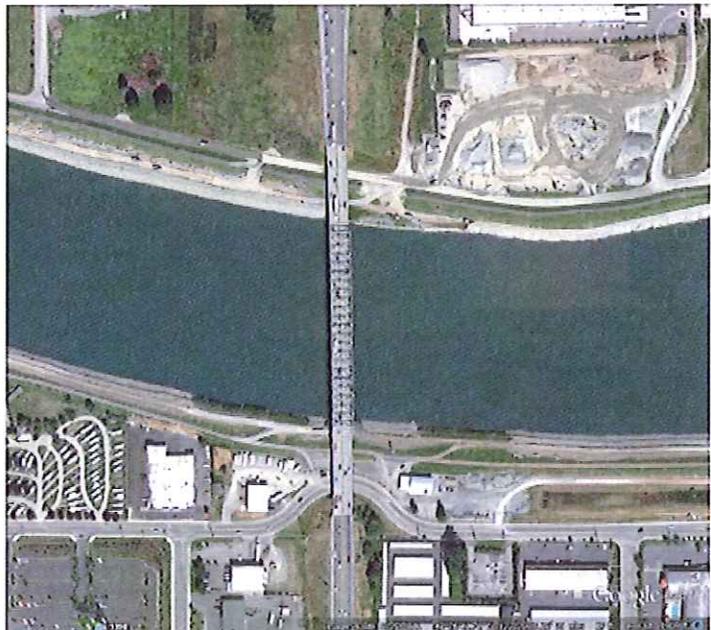
The Skagit River Bridge was constructed in 1955. Inspections have shown<sup>4</sup> that the bridge was functionally obsolete as early as 1983, but has been rated fair to satisfactory in all categories (deck, superstructure, and substructure conditions) since 2005. A bridge rated as functionally obsolete means that the bridge was constructed to outdated standards, not that it is classified as unsafe. The construction of the Thru Truss Structure of the bridge limits overhead clearance in the right lanes due to the oblong shape of the lower sway brace. The braces are lower over the right lanes near the edge than it is in

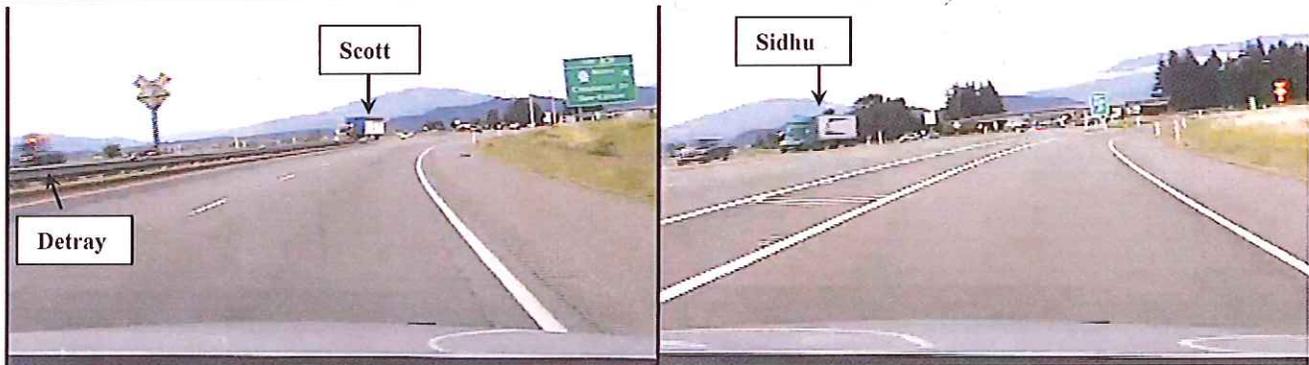
At about 7:05 p.m., Tammy Detray and William Scott entered the Skagit River Bridge in the right lane. Detray estimated her lead at 4 ~ 5 seconds and stated her height pole did not strike the bridge (sway braces). She noticed a semi-truck next to the load as it entered the bridge behind her. Detray was on her cellular phone, hands free, talking to her husband. While watching through her mirrors, Detray saw dust and the bridge collapse so she stopped on the right shoulder south of the bridge and contacted Scott.

Scott said he was going approximately 56 ~ 58 mph as he entered the bridge. He told investigators that the pilot vehicle was approximately half way across the bridge in the right lane (550 feet); or about a half a mile ahead with plenty of distance for him to stop if the pilot driver alerted him. Scott stated that a white tractor combination was passing him, moving fast and “squeezing” him. This truck was in fact Amandeep Sidhu. The photo below taken from Foothills Toyota surveillance video shows both trucks on the bridge right before the collision.
